Risk Analysis of Vegetation on Levees

Donald C. Tillman Water Reclamation Plant

Located at the margin of the Sepulveda Flood Control Basin, Woodley Park, Van Nuys, CA

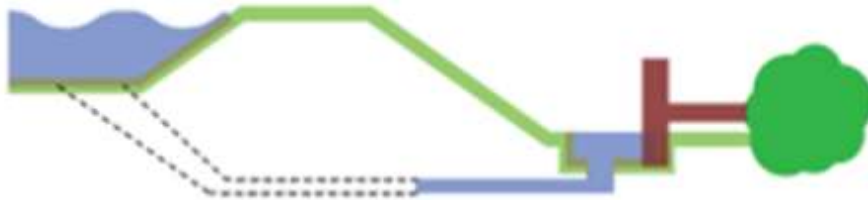
PFM 2 *Oak tree on slope of protected side topples creating a seepage path*

During reservoir loading, high winds cause an oak tree on the slope of the protected side of the berm to topple. The fallen tree dislodges a root ball shortening the seepage path through the berm. The head from water in the reservoir drives seepage, which egresses in the cavity left by the root ball. Piping of the foundation soil initiates at the root-ball cavity and backward erosion occurs until a pipe forms to the reservoir. Rapid erosion enlarges the pipe until the crest of the berm collapses and water rushes into the plant site.
