Marine Transfer Station Coastal Storm Surge Vulnerability Assessment

Prepared for: New York City Department of Sanitation

Prepared by: HDR Engineering

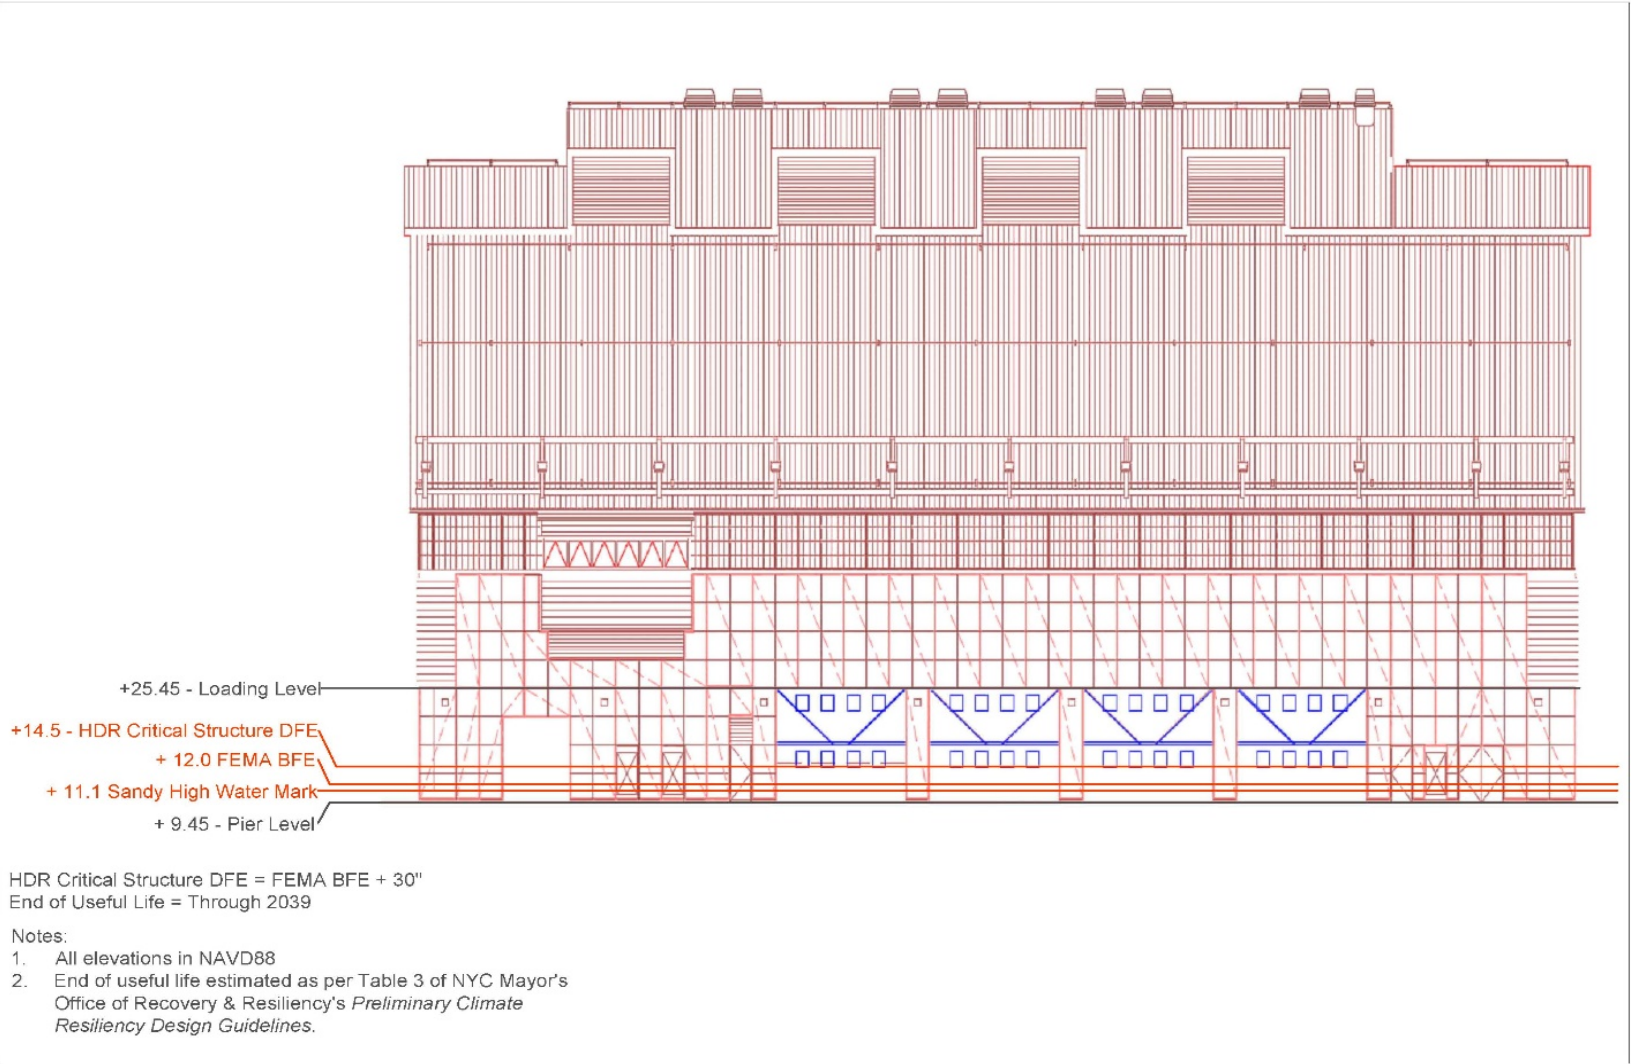
Hamilton Avenue Profile

Design Flood Elevation: +14.50			
Pier Level : +9.45			
Critical Area	Vulnerability Type	Number of Vulnerabilities	Comments
Combined Sewer Connection	Backflow	1	Discharges to sewer manhole
Stormwater Outfall	Backflow	2	Discharges to Gowanus Canal
Bilge Lines	Backflow	2	Connects to interior drainage
Exterior Walls	Inflow	52	Door, window, crane box, utilities
Electrical Room	Inflow	2	Door
Fire Pump and Meter Room	Inflow	8	Door, utilities
HVAC Room	Inflow	9	Door, utilities

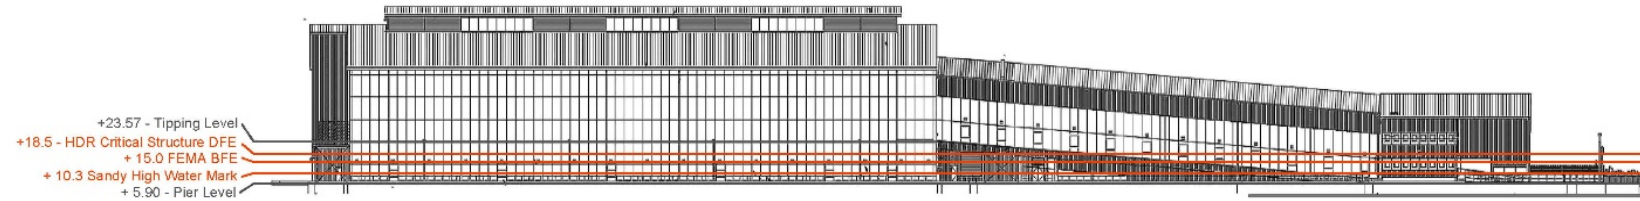
59th Street Profile

Design Flood Elevation: +18.50			
Pier Level : +5.90			
Critical Area	Vulnerability Type	Number of Vulnerabilities	Comments
Sanitary Sewer Connection	Backflow	1	Discharges to sewer manhole
Electric Room #2 ⁽¹⁾	Inflow	9	Ducts, doors, fans, utilities
Fire Protection Room ⁽¹⁾	Inflow	2	Door, louver
Emergency Generator Room ⁽¹⁾	Inflow	10	Door, louver, exhaust, utilities
Mechanical Room ⁽¹⁾	Inflow	10	Door, louver, utilities
Operations Building	Inflow	26	Door, window, fixture, utilities
Note: ⁽¹⁾ Has flood protection barriers.

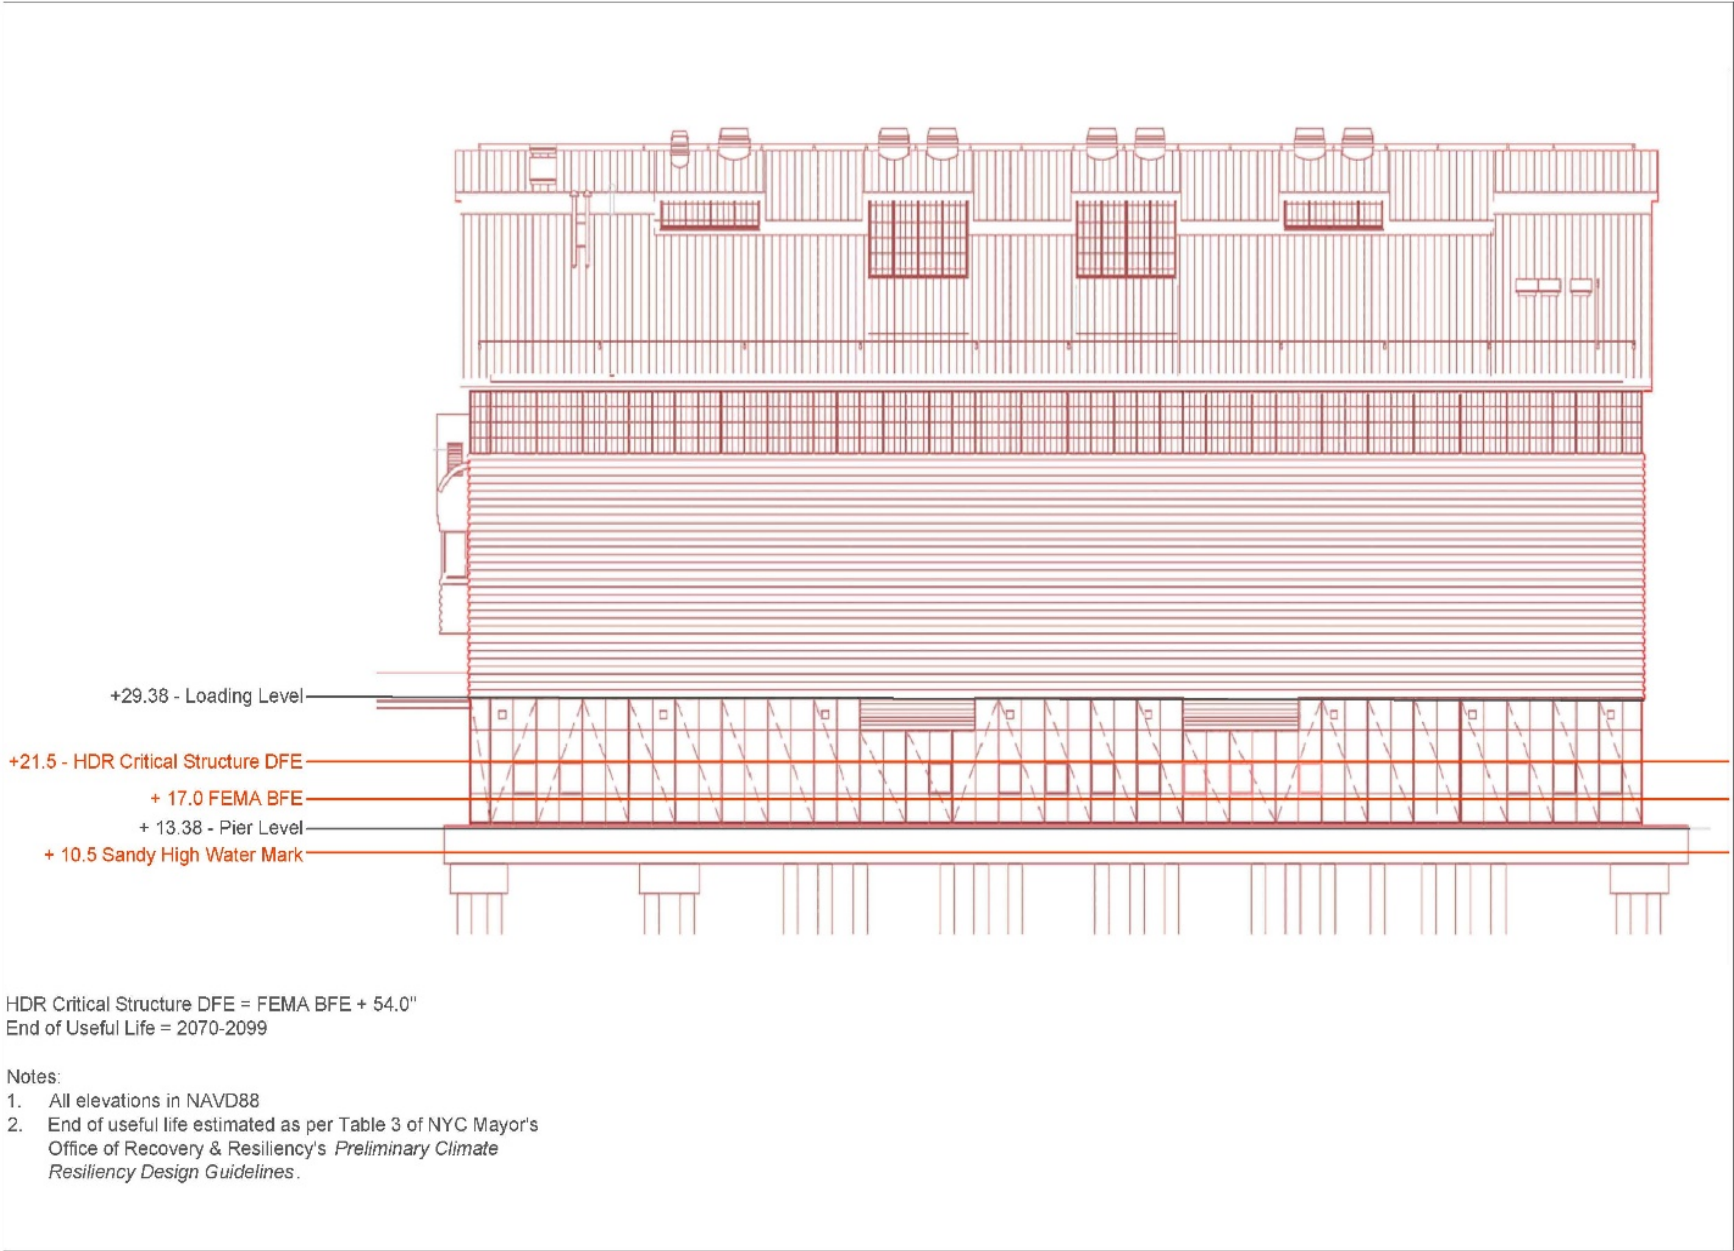
North Shore Profile

Design Flood Elevation: +21.50			
Pier Level : +13.38			
Critical Area	Vulnerability Type	Number of Vulnerabilities	Comments
Sanitary Sewer Connection	Backflow	1	Discharges to sewer manhole
Stormwater Outfall	Backflow	3	Discharges to Flushing Bay
Roof Drain	Backflow	4	Discharges to Flushing Bay
Exterior Walls	Inflow	45	Door, window, louver, utilities
Ejector Room	Inflow	4	Door, utilities
Electrical Room #1	Inflow	1	Door
Fire Pump and Meter Room	Inflow	10	Door, utilities
HVAC Room	Inflow	7	Door, utilities
Separator Room	Inflow	4	Door, utilities

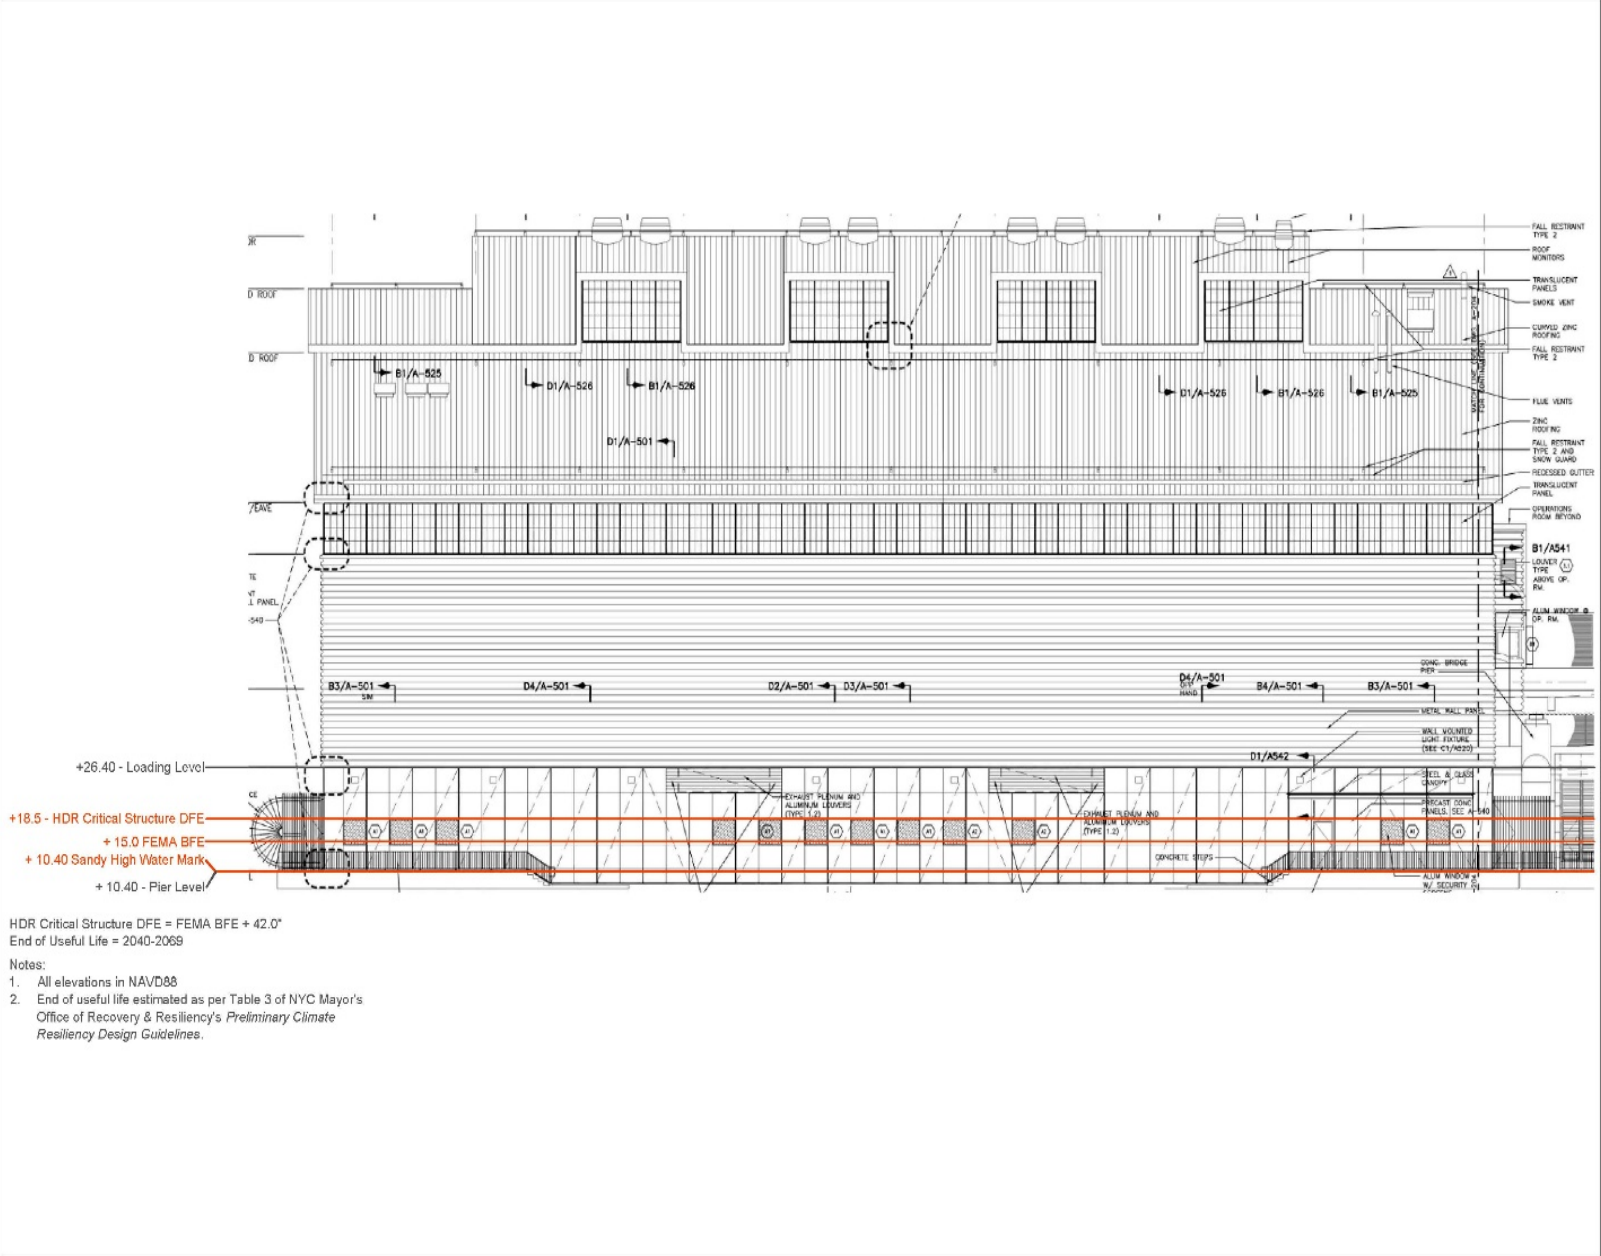
East 91st Profile

Design Flood Elevation: +18.50			
Pier Level : +10.40			
Critical Area	Vulnerability Type	Number of Vulnerabilities	Comments
Combined Sewer Connection	Backflow	1	Discharges to sewer manhole
Stormwater Outfalls	Backflow	5	Treatment units and connections
Exterior Walls	Inflow	39	Door, window, crane box, utilities
Ejector Pump Room	Inflow	3	Door, utilities
Electrical Room	Inflow	2	Door
Fire Pump and Meter Room	Inflow	11	Door, utilities
HVAC Room	Inflow	9	Door, utilities
Separator Room	Inflow	6	Door, utilities
