# Goodwin Fire Post-Burn Runoff Calibration

Yavapai County, Arizona

Dan Cherry, Yavapai County

Linda Potter, Atkins North America, Inc.

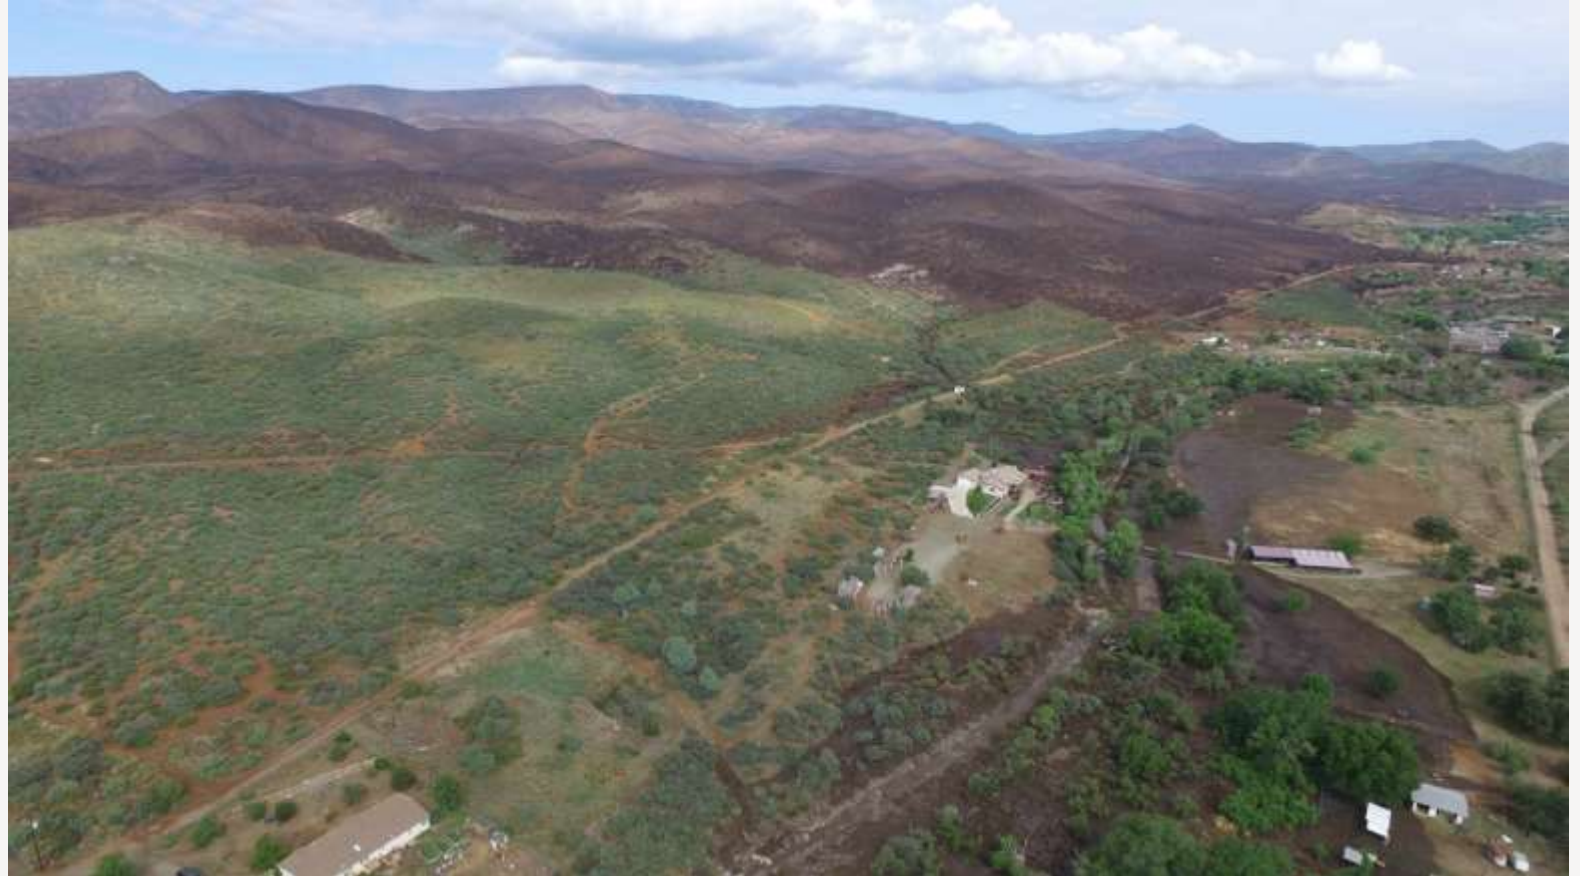
# Gage installation

Four new gages installed in burned watershed, two existing gages

- › Grapevine Canyon
- › Big Bug Mesa
- › Upper Hackberry
- › Radar flow sensor on State Route 69 at Big Bug Creek

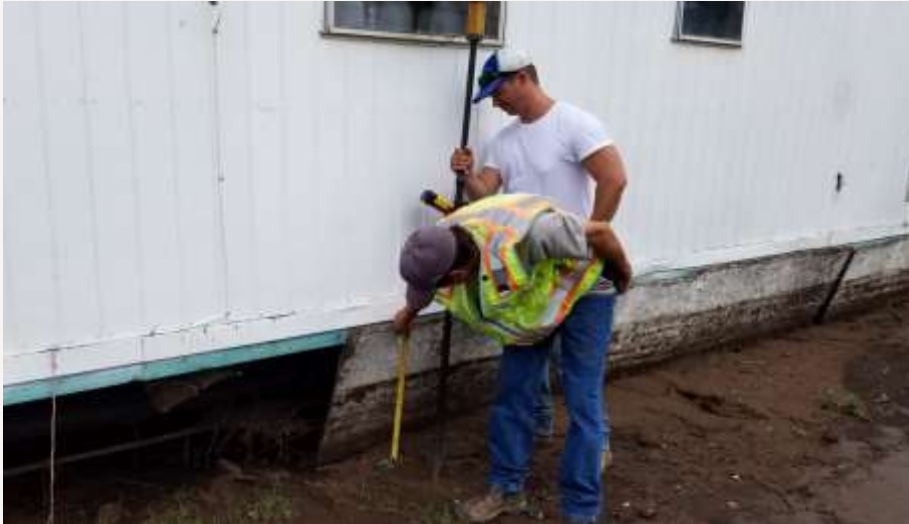
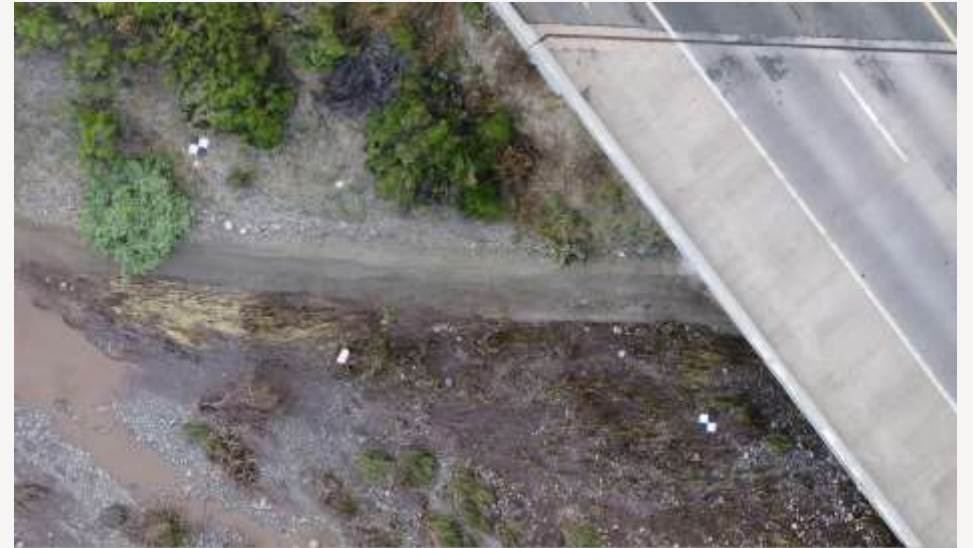
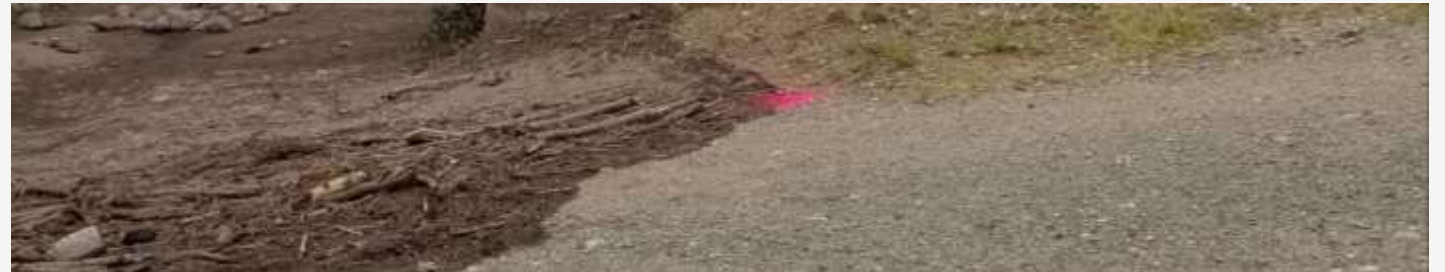
# High water marks, post-flood data collection

- › Time was of the essence
- › Ash residue, water marks, and flotsam
- › Gathered flood inundation limits, cross sections, high water marks
- › Drone aerial and ground photography and video

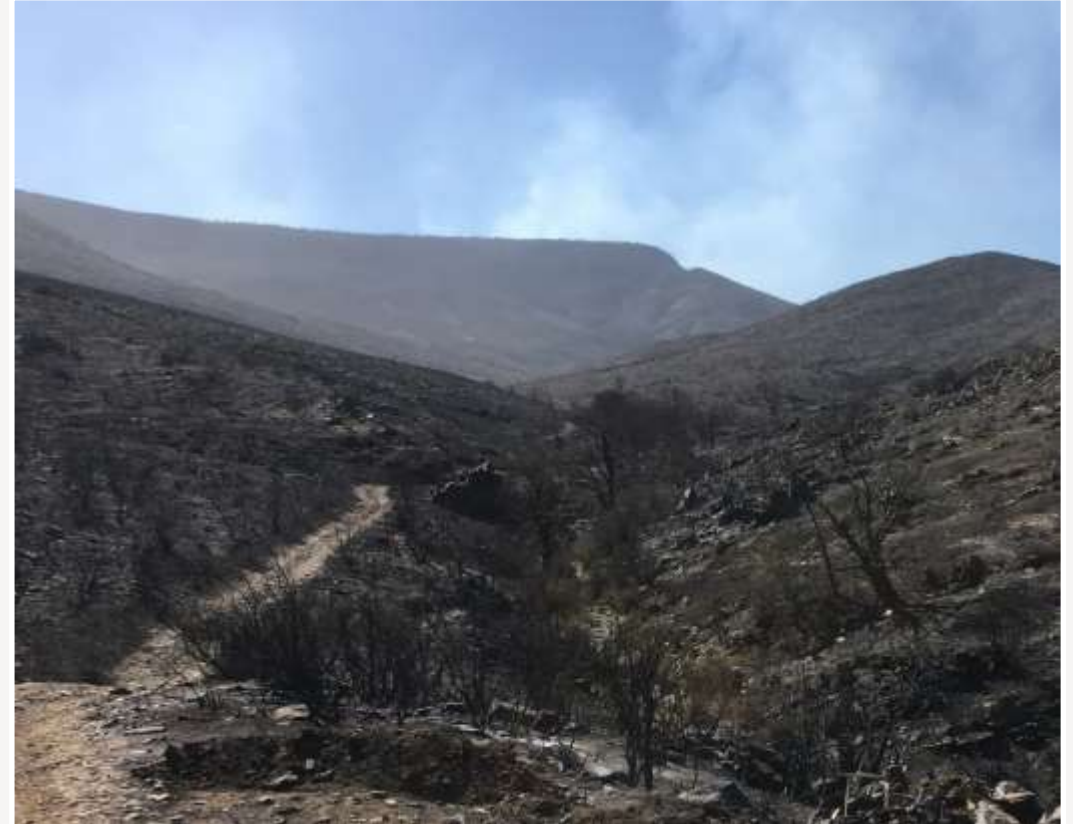
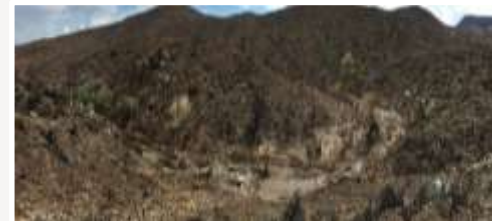
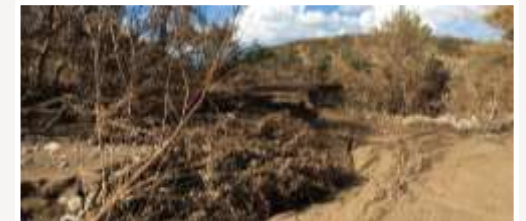
# Calibration steps

1. Precipitation into model
2. Routes in burn area
3. Trial and error – CN and Lag

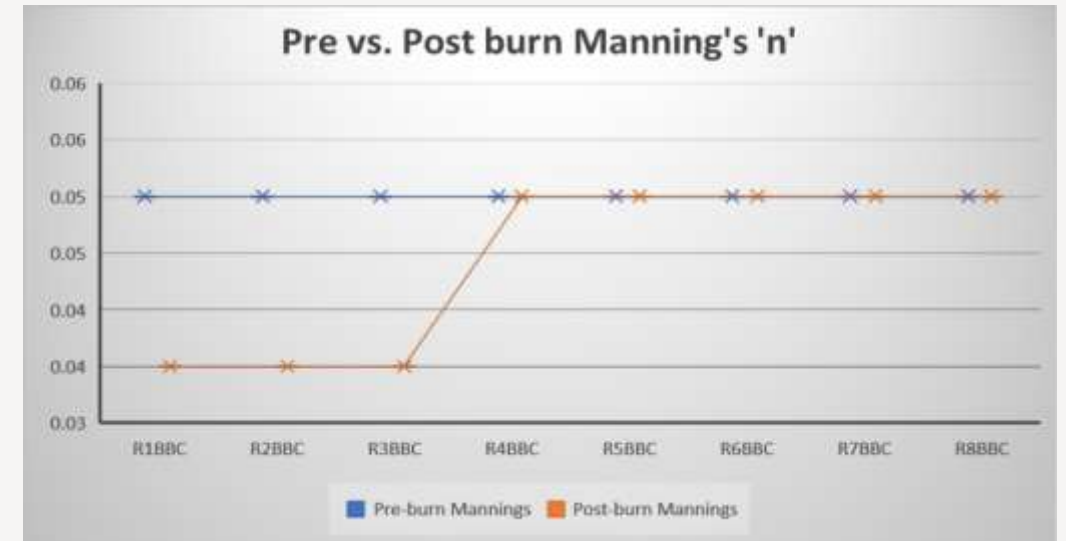
# Reach routing

Roughness reduced in burn areas from 0.05 to 0.035

Account for reduction in vegetation

In Arizona, vegetation is in the channel

Routing roughness adjustments for burned areas as applicable

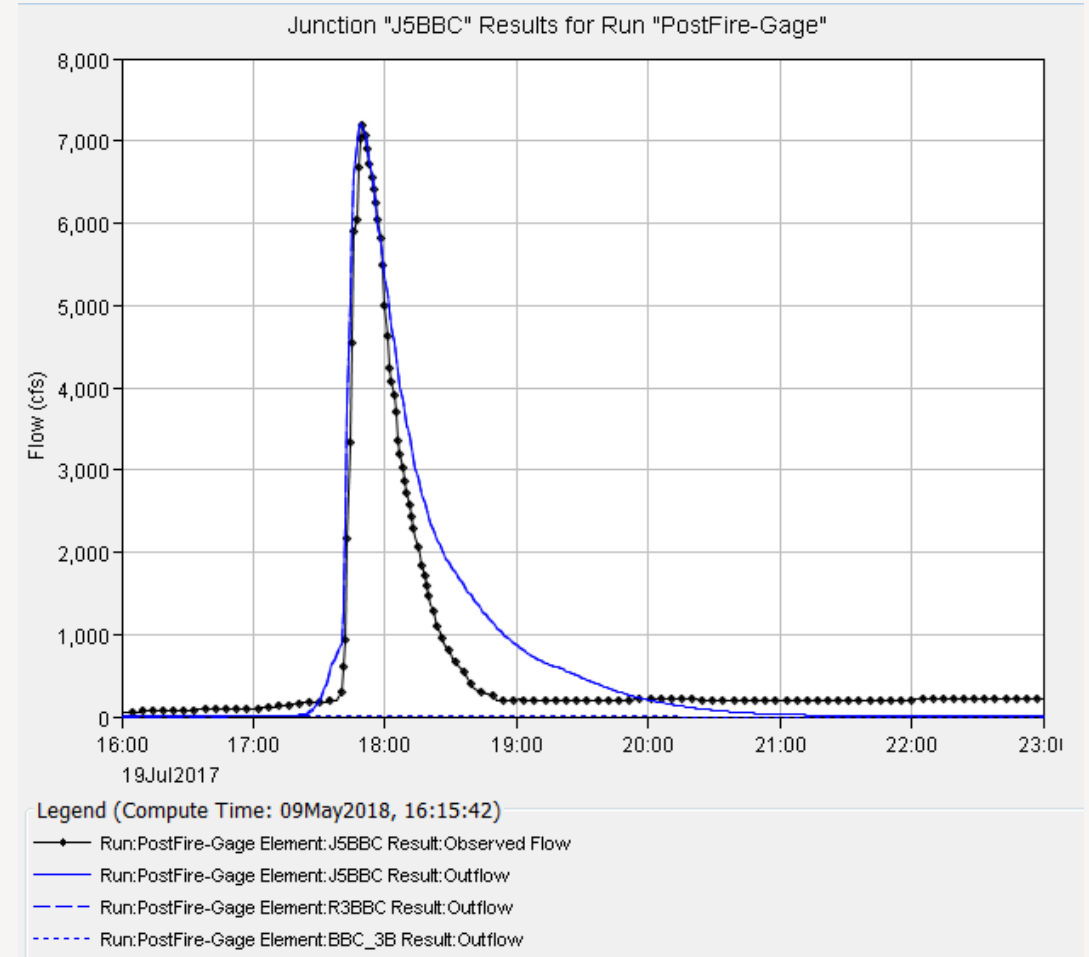
# Results

Good match in timing and peak

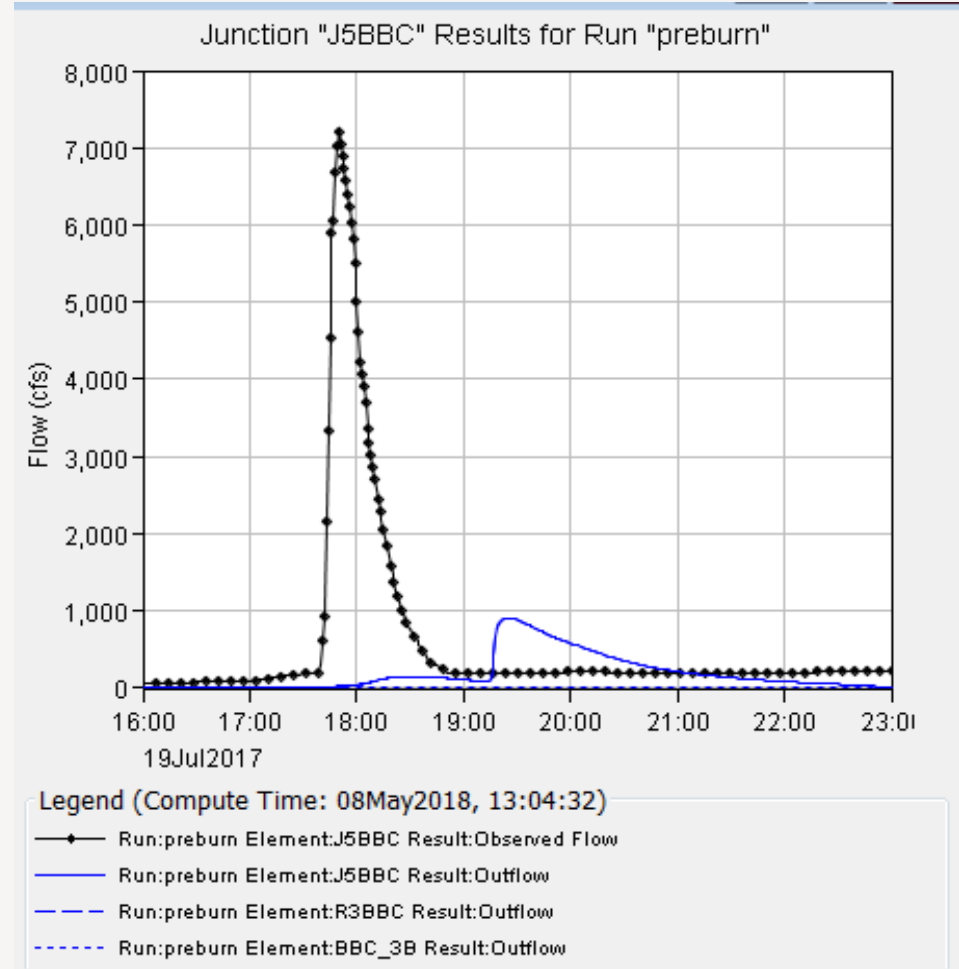
# Results

Post burn runoff for this storm:

7x pre-burn conditions

1.5 hours faster arrival time at S.R 69
