Northeast Ohio Regional Sewer District

Regional Stormwater Management Program

Case Study: Beechers Brook

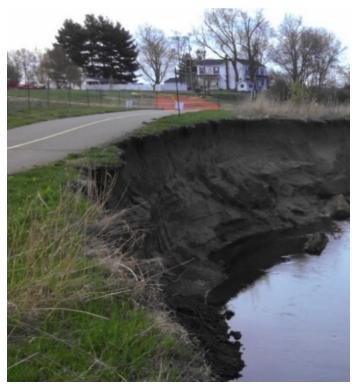
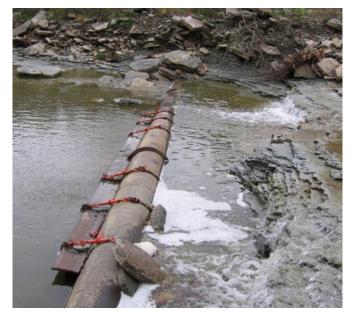
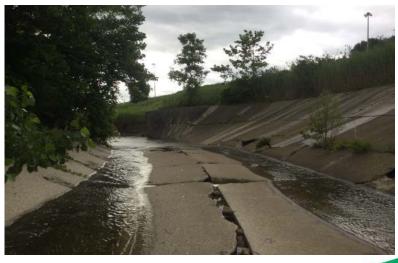
What is "Targeted" Stream Restoration?

- Streams are dynamic, subject to horizontal and vertical adjustments
- Rate of adjustment can accelerate when disturbed (floodplain loss, hydrologic changes, channel straightening, etc.)
- Asset Protection: utilities, transportation, buildings, recreational amenities (paths, shelters, etc.)

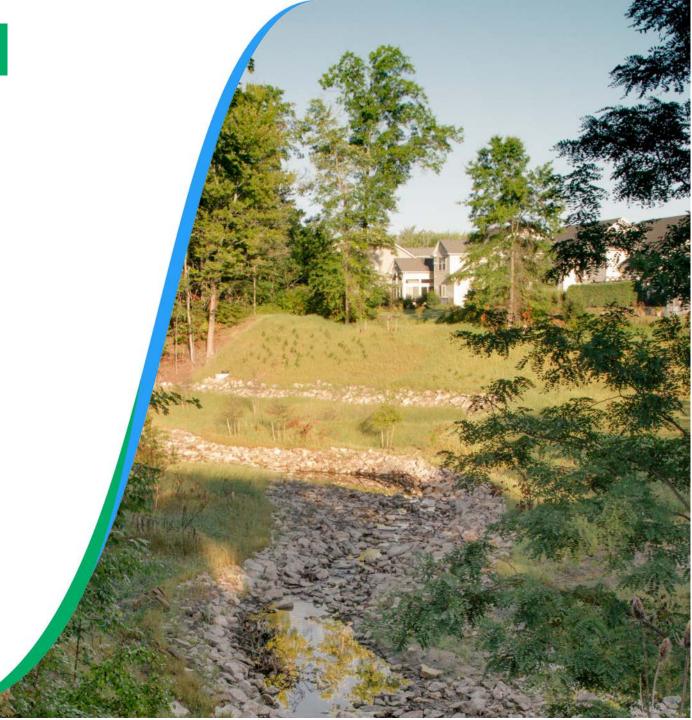
Natural Channel Design

- Initial Stream Assessment
- Grade Control Improvements (riffles/ pools, cross-vanes, J-hooks, etc.)
- Reconfigured Channel Sections (reestablished floodplains, reduced bank slopes, bankfull benches)
- Permanent and Temporary
 Stabilization (toe rock, vegetation, erosion control blanket)

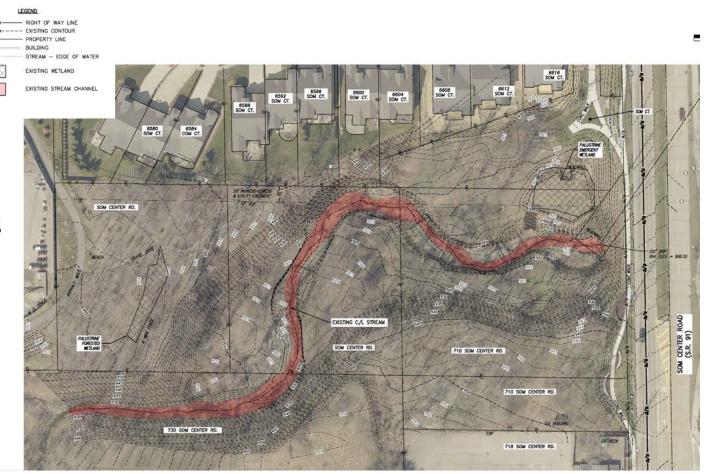
- Site Conditions:
 - o Urbanized Watershed, 1.6 mi²
 - Adjacent Residential neighborhood
- Project Goals
 - Protect / Improve Water Resources
 - Address Flood / Erosion Concerns
 - Enhance Water Quality and Aquatic Habitat
 - Asset Protection
- Total Restoration Length 800-ft

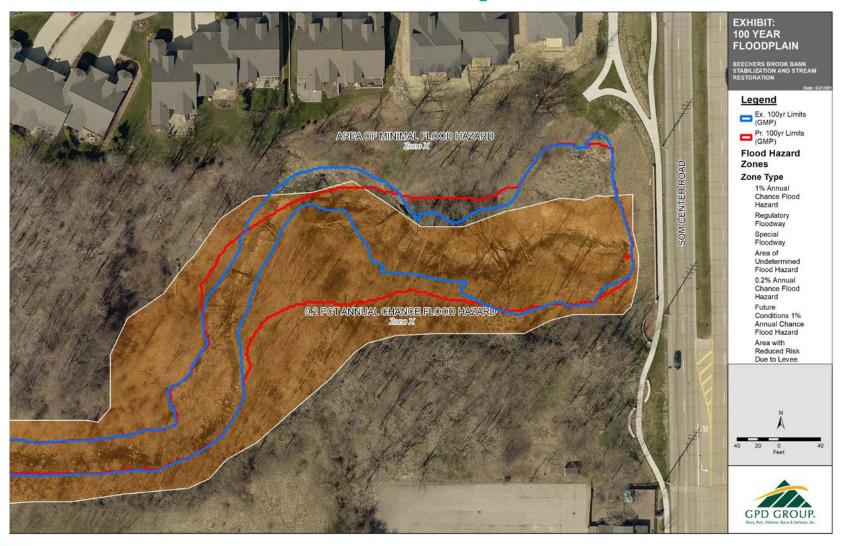
Beechers Brook - Floodplain

- Floodplain limits
 - Increase
- Code Requirements
 - Permits
 - Variance

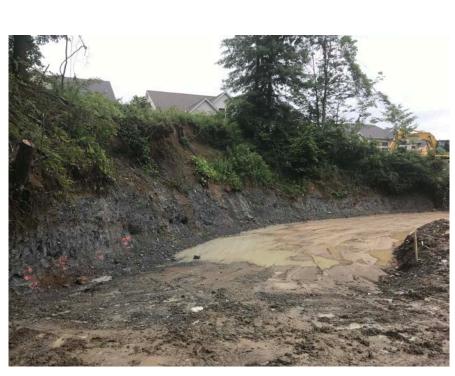
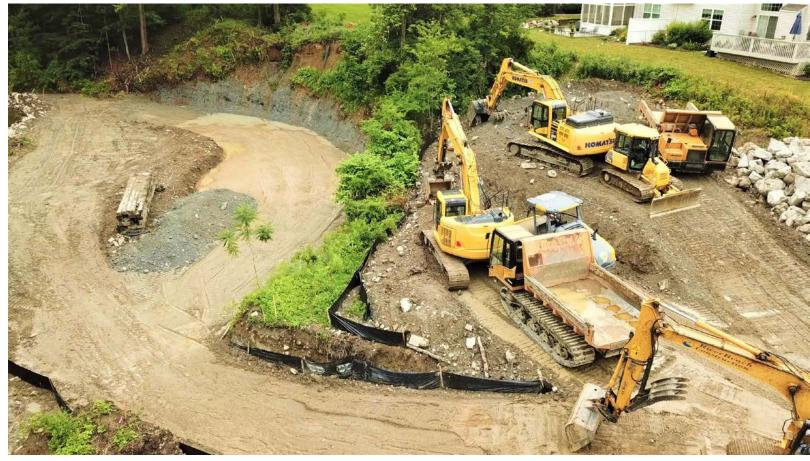
Beechers Brook - Restoration

- Raised Grade
- Reestablish Floodplain
- Channel Improvements
 - o Riffles / Pools
 - o Bank Stabilization
 - Headcut Stabilization
 - Grading
 - o Rock Toe
- Outfall Stabilization

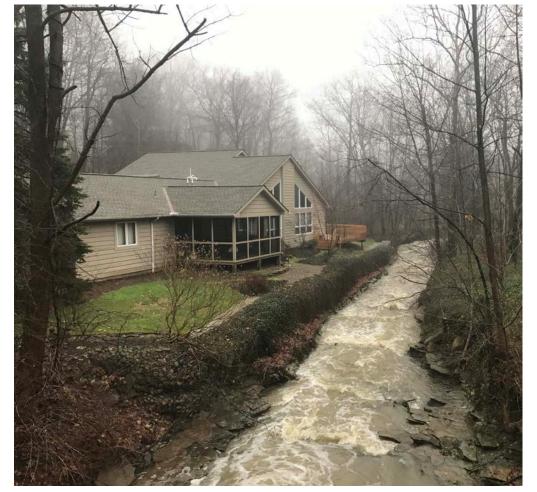
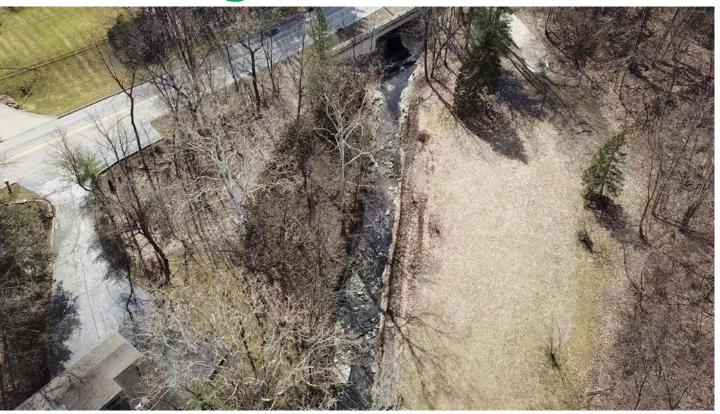
Pepper Creek- Existing Conditions

- Site Conditions:
 - o Urbanized Watershed, 1.36 mi²
 - Existing homes adjacent to stream
 - Entrenched stream
- Project Goals
 - Protect / Improve Water Resources
 - Address Flood / Erosion Concerns
 - Enhance Water Quality and Aquatic Habitat
 - Asset Protection
- Total Restoration Length 900-ft

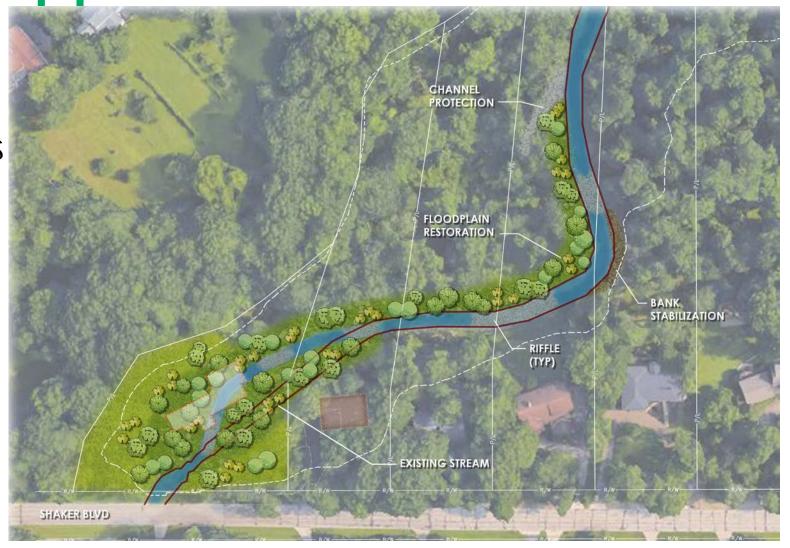
Pepper Creek

- Raised grade
- Reestablish Floodplain
- Channel Improvements
 - o Riffles / Pools
 - o Bank Stabilization
 - Grading
 - o Rock Toe

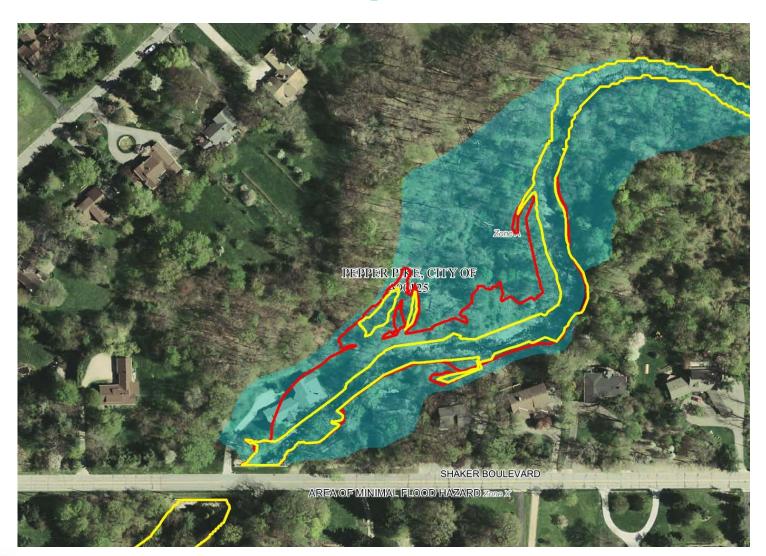
Pepper Creek - Floodplain

- Floodplain limits
 - Increase
- Code Requirements
 - Permit
 - Variance

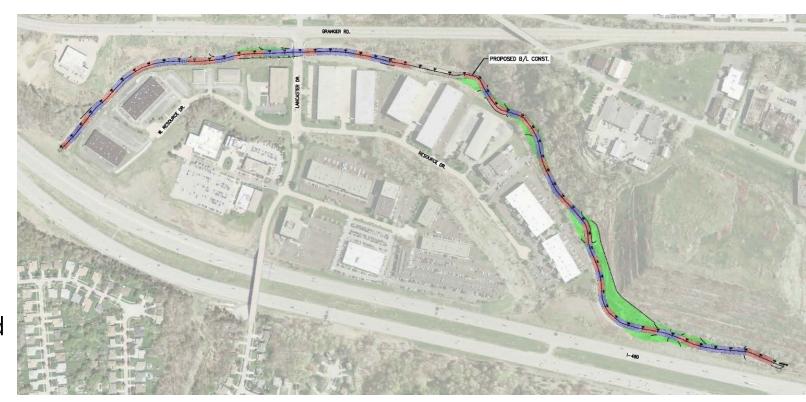
Case Study: West Creek

- Site Conditions:
 - o Urbanized Watershed, 9.2 mi²
 - Adjacent Landfill
 - Historic Stream Impacts
- Project Goals
 - Asset Protection
 - Protect / Improve Water Resources
 - Address Flood / Erosion
 Concerns
 - Enhance Water Quality and Aquatic Habitat
- Total Restoration Length 6,000-ft

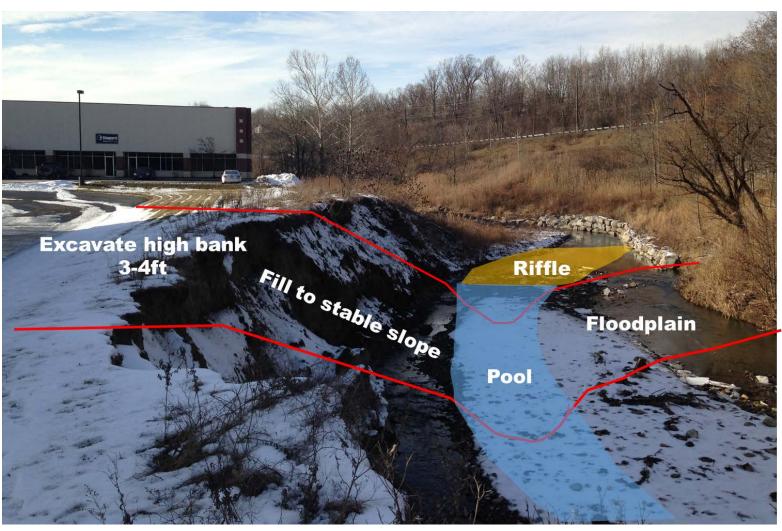
West Creek Improvement Options

- Reestablish Floodplain
- Channel Improvements
 - o Riffles / Pools
 - Bank Stabilization
 - Headcut Stabilization
 - Grading
 - o Rock Toe
- Outfall Stabilization
- Utility Protection
- Flume Restoration

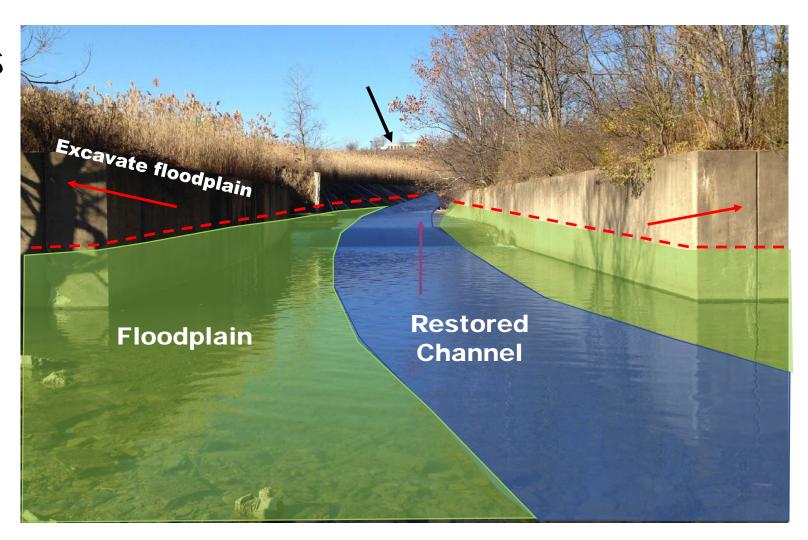
West Creek Flume - Restoration

- Eliminate Fish Passage Barrier
- Lower Stream Energy (gradient, floodplain)
- Maintain Conveyance Capacity
- Plan for Public Outreach

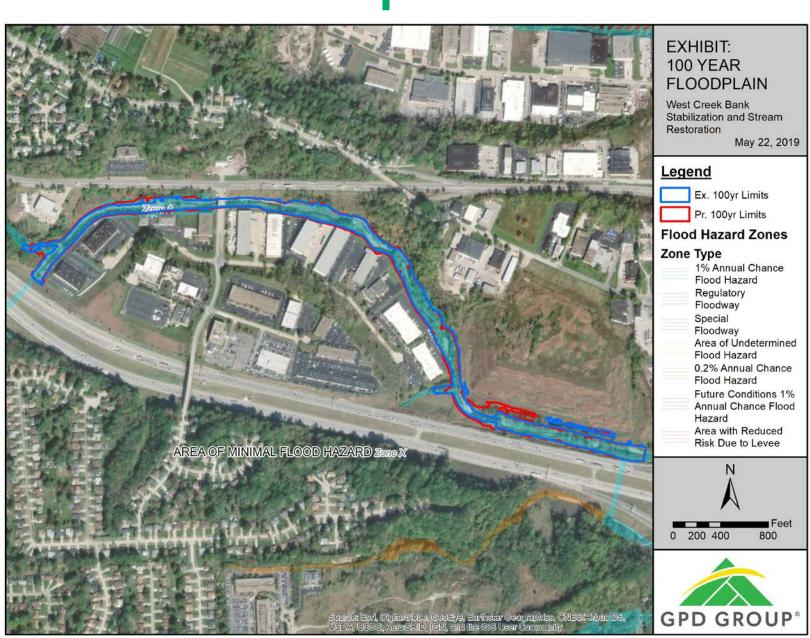
West Creek - Floodplain

- Floodplain limits
 - Increase
- Code Requirements
 - Permits
 - Variance
