Evaluating your FPM building design and construction requirements in a post-disaster environment

Cleveland, Ohio

May 22, 2019

*FLOOD FEST
2019: The
Mitigation &
Resilience
Tour*

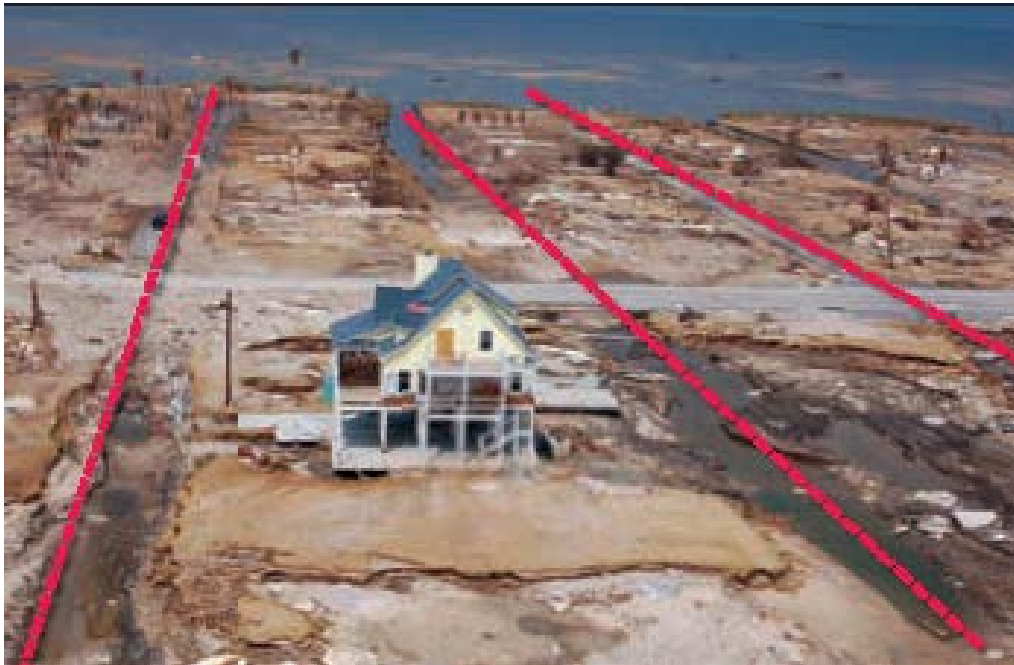
Figure 3-22. Linear scour features tend to align with canals and roads as storm surge returns to the Gulf. Houses such as this one were fortunate not to be undermined and lost during Ike, as many homes undoubtedly were (Bolivar Peninsula, TX).

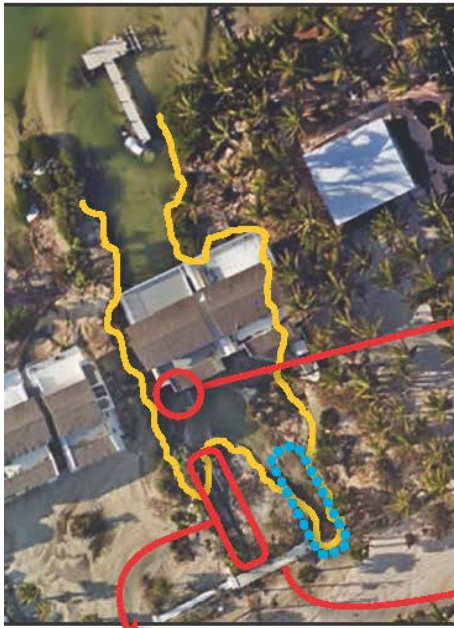
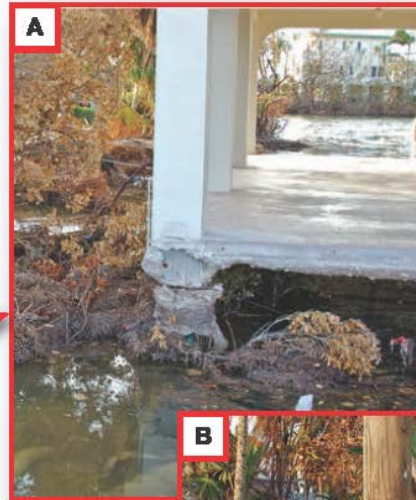
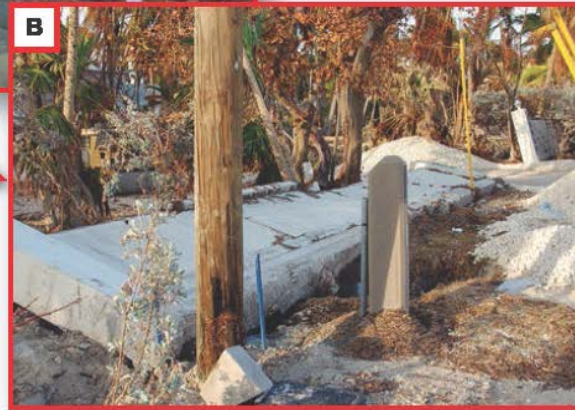
Scour [A] may have been increased by privacy walls [B], driveways (dotted blue line), and utility placement that led to preferred flow paths [C]. Water depth approximately 30" above slab. Yellow line indicates boundary of the area scoured. Figure 3-14 (Lower Matecumbe Key, FL)

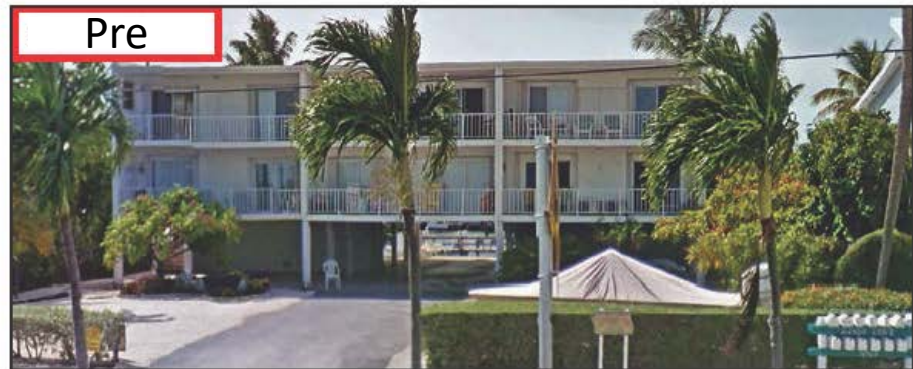
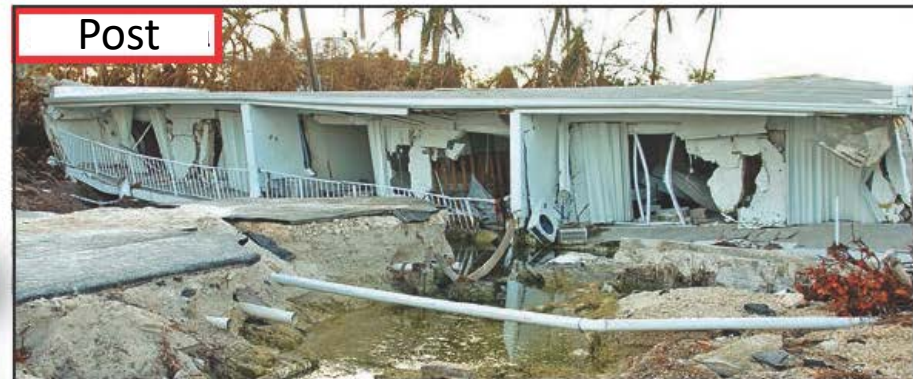
Yellow line indicates boundary of the area scoured. The MAT did not determine whether scour contributed to the collapse. Figure 3-17 (Lower Matecumbe Key, FL)

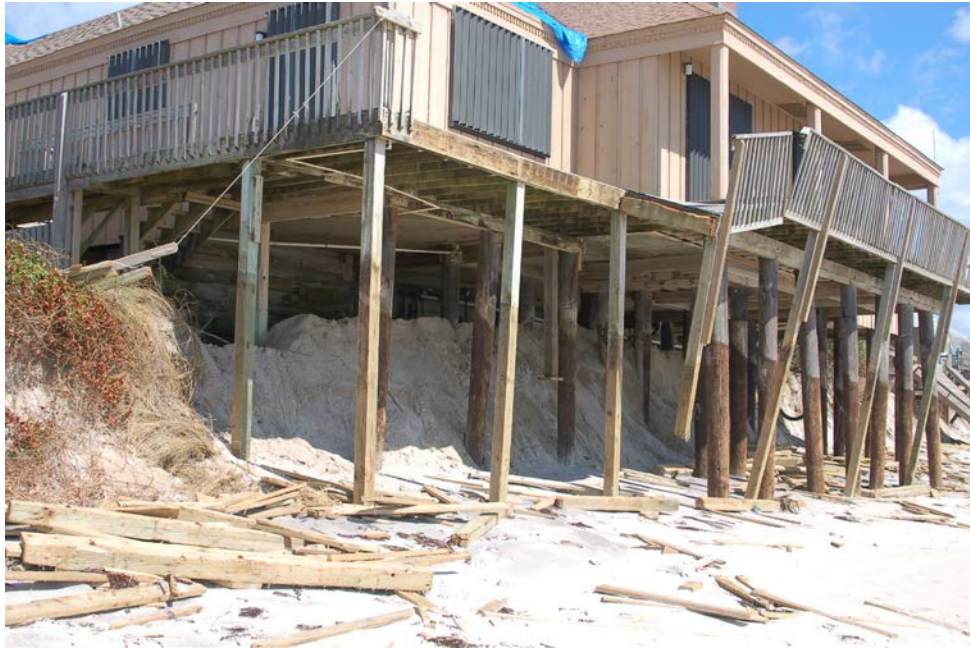
Hurricane Florence, North Carolina
Shallow deck supports into frontal dune.

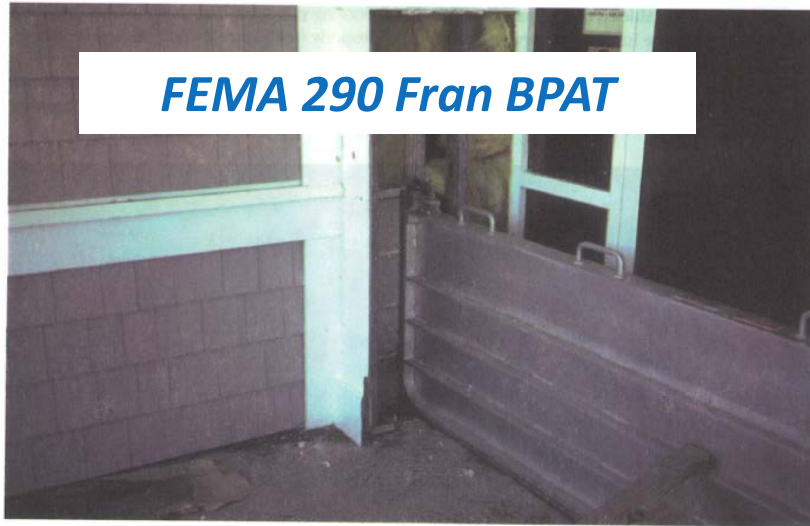
Figure 2-40 Engineered flood shield installed over opening to large dry floodproofed commercial building.

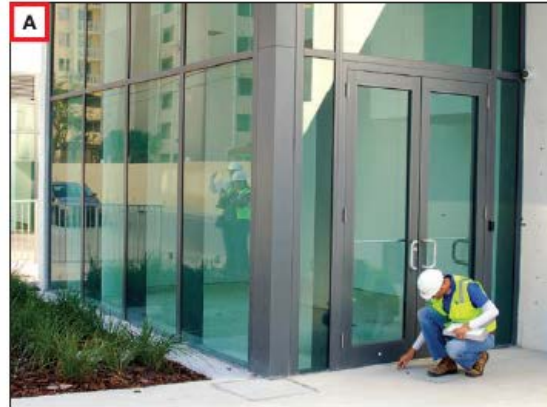
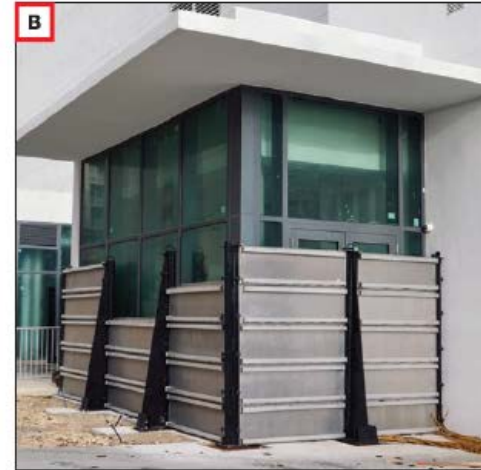
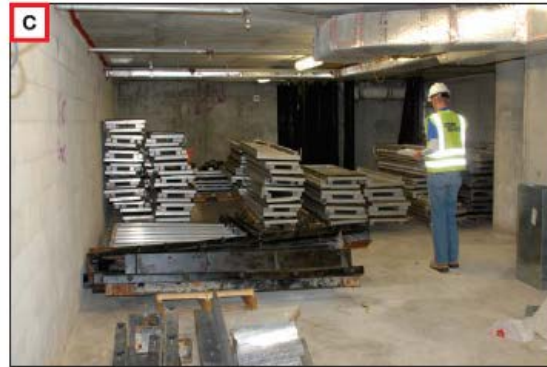
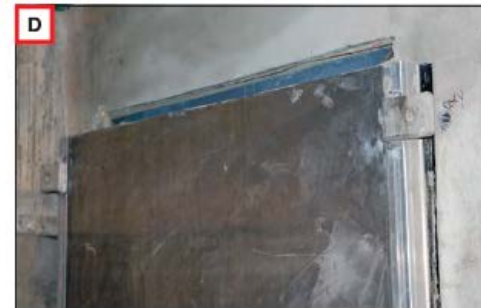
FEMA P-2023 Hurricane Irma in Florida MAT Report Figure 3-31: A high-rise residential building under construction was successfully protected by a dry floodproofing method that used flood panels and doors; the floodproofing was installed by the building contractor (Miami, FL)

The doors without [A] and with [B] the floodproofing system deployed. [C] shows the panel and post storage room. [D] shows a gap at the top of a doorway flood shield.
System took 10 workers 2 full days to install.

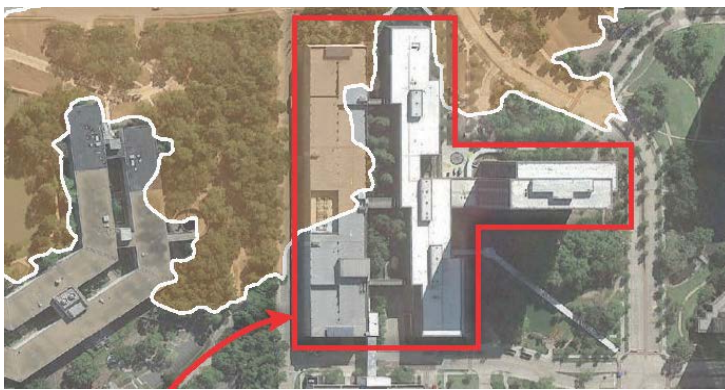
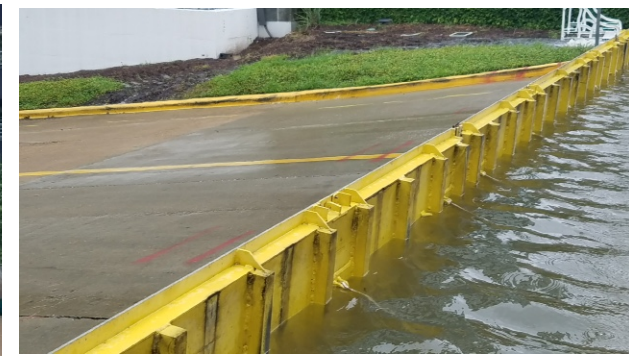
Orange temporary flood barriers are visible along the east side of the complex, but are submerged along the southeast corner of the parking garage where the grade elevation is lower.

Figure 3-68 through 3-71
The passive floodgate was not overtopped.

Floodwater entered via the parking garage and by overloading an

- A. unreinforced masonry wall used to infill a below-grade wall penetration to an
- B. unused utility vault.
- C. Understanding the potential source of flooding
- D. is critical.

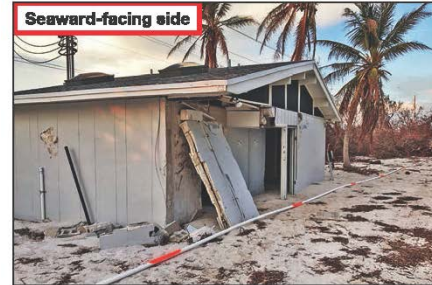
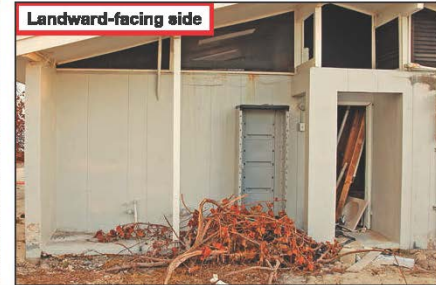
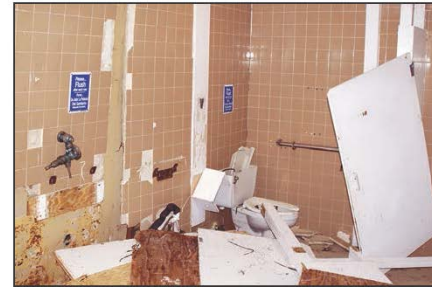
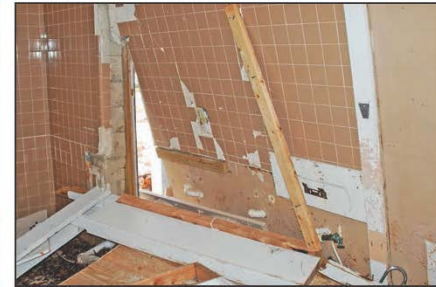
The bottom photos show damage to fixtures, partitions, and walls that was likely caused by waves and high-velocity flow. The restroom was demolished between the pre-MAT and MAT visits.

Figures 3-41 & 42: Restroom in Long Key State Park that sustained structural flood damage. Elevated restroom with ground-level enclosure at Bahia Honda State Park, flood depth in enclosure was 5 feet.
(Monroe County)

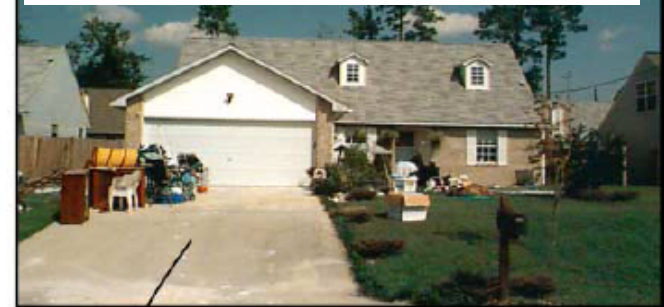
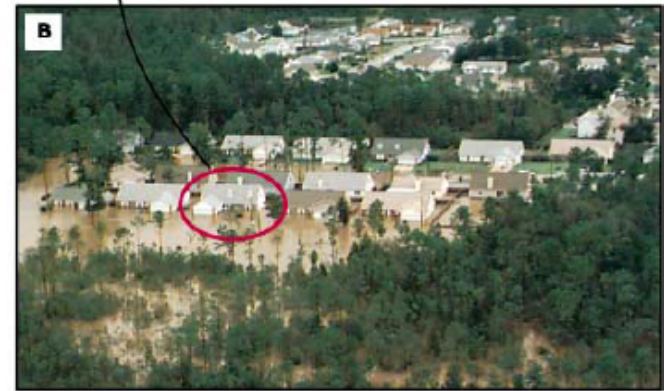
FIGURE 5-3 The home pictured above is one of approximately 10 homes in this subdivision which experienced flood depths of 2 to 3 feet when the water levels exceeded the BFE and extended beyond the limits of the SFHA.

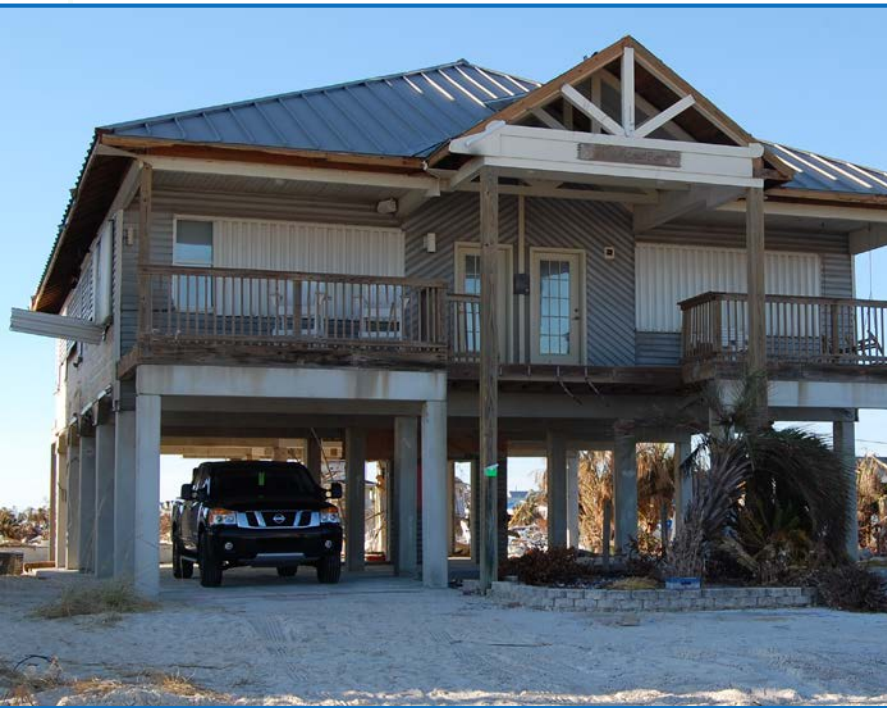
Table 91. Prototype 7A: Building on Open Pile Foundation, Inundation Damage – Structure

Flood Depth	Min	Most Likely	Max
-9	0	0	0
-8	0	0	2
-5	1	2	10
-3	2	4	12
-1	2	12	20
-0.5	6	16	25
0	7	20	32
0.5	12	28	35
1	30	35	55
2	35	40	70
3	40	60	80
5	50	70	100
7	60	80	100
10	82	100	100

Figure 107. Prototype 7A: Building on Open Pile Foundation, Inundation Damage – Structure
